# Inspection Report

## Runge Building & Consulting

## Property Address:

1234 Blank St.

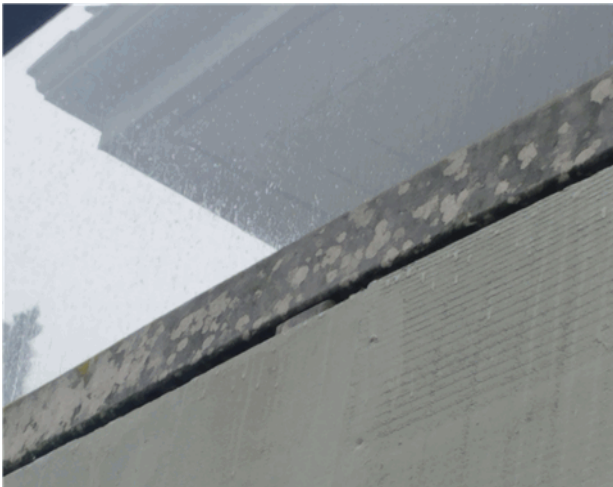
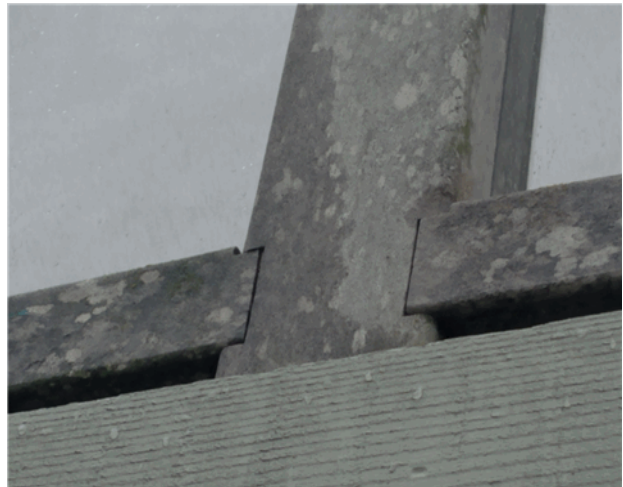
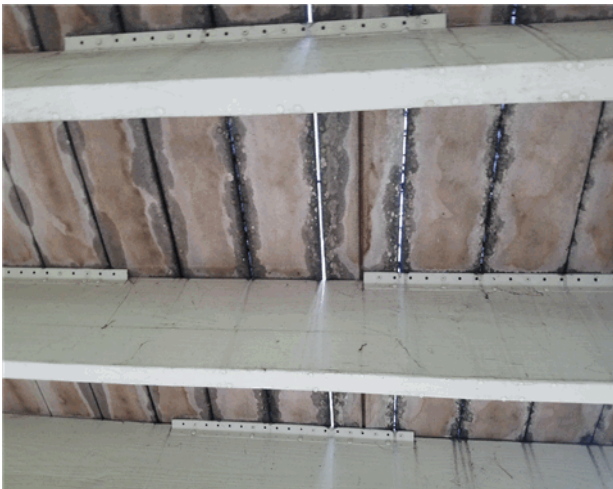
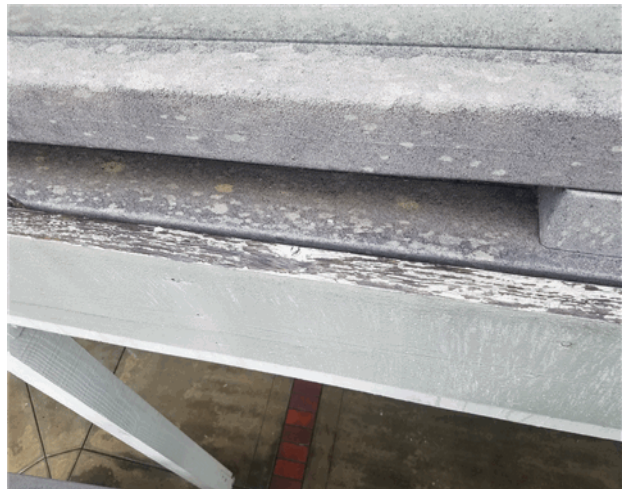
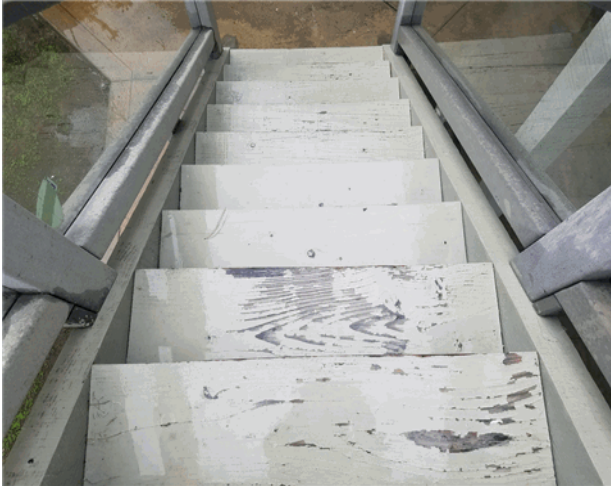
### 6) Back Entrance Conditions

There is moss growing on the synthetic wood of the 2nd floor deck. There are several areas of loose or missing paint on the deck wood members and the stairs.

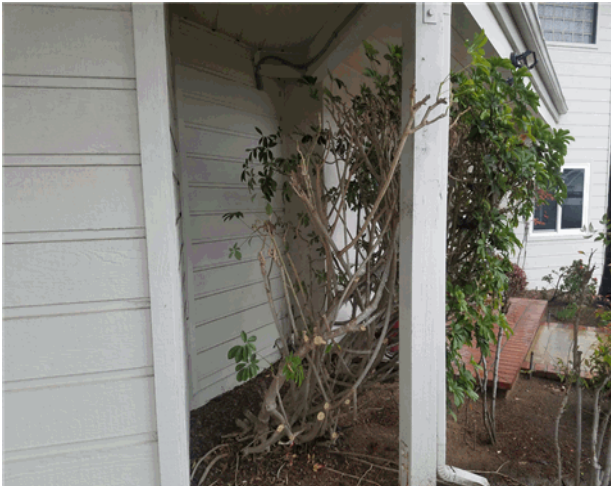
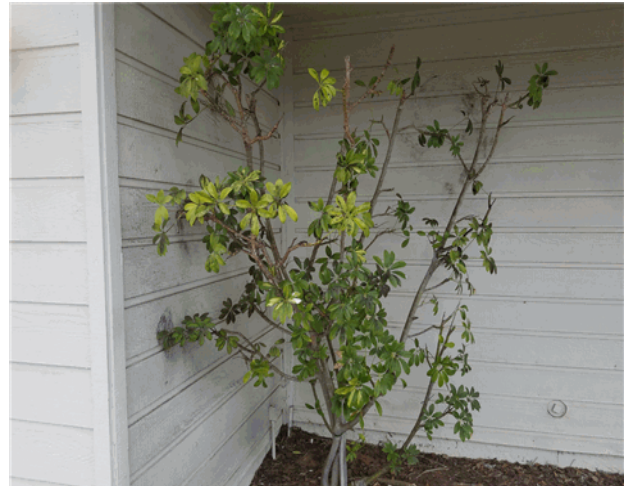
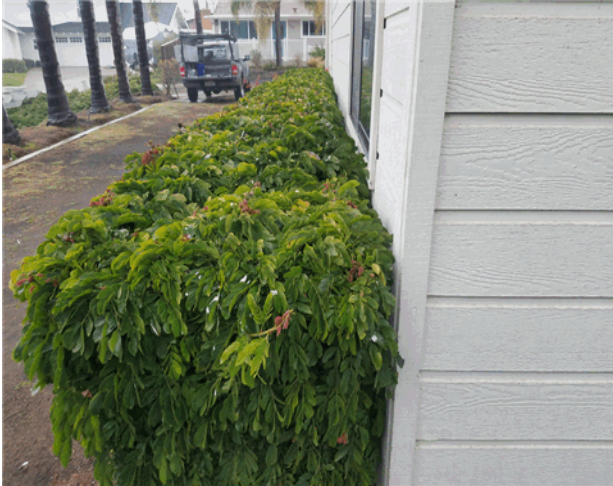
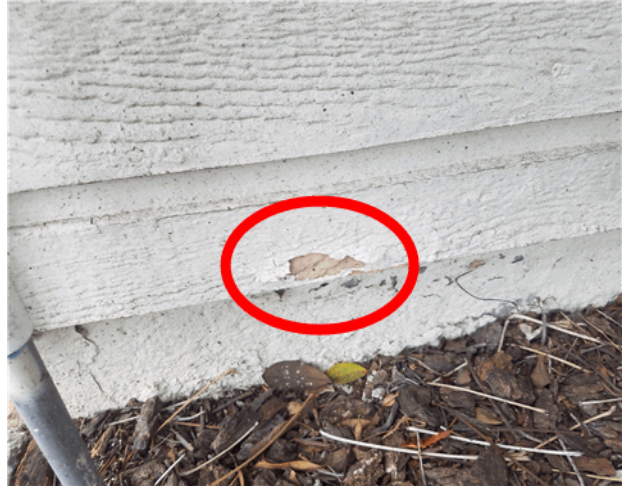
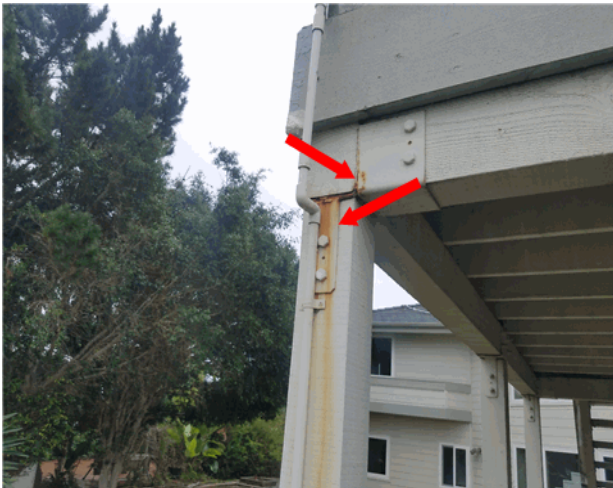
**7) Exterior Wall Conditions**

Vegetation was in contact with the exterior walls. The vegetation should be trimmed away 1 - 2 feet from the wall. The exterior walls were not fully visible due to overgrown vegetation. The paint / finish of the siding / walls was weathered and rust stained in some small areas.

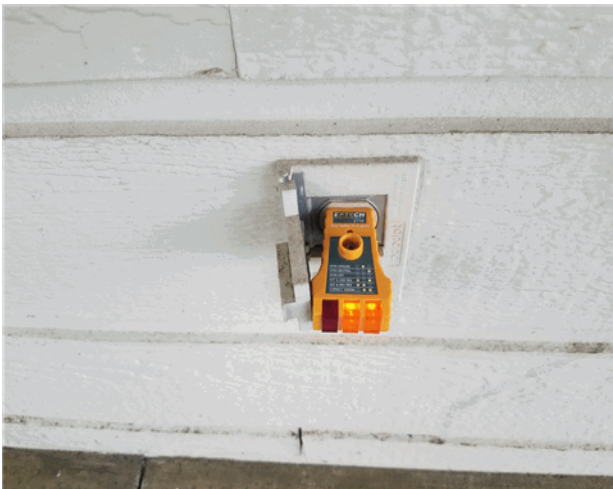
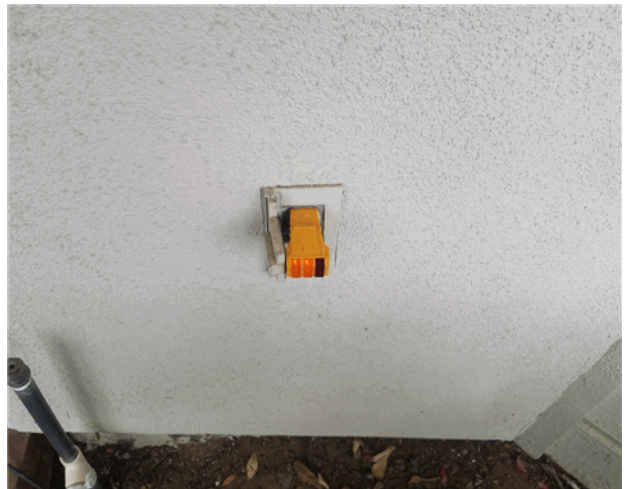
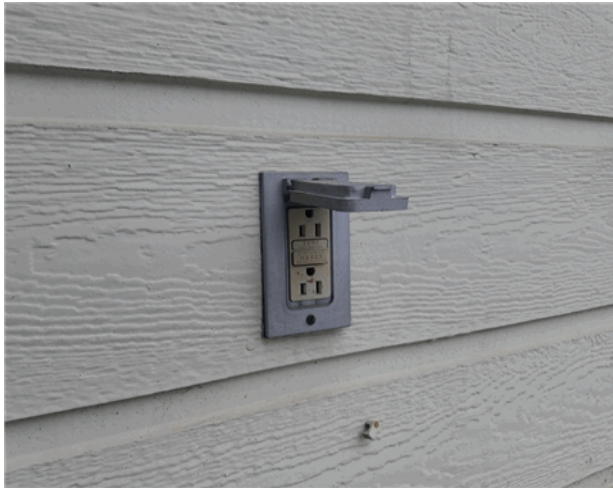
**8) Exterior Electrical**

Some of the outlets are not GFCI protected. Others have old but working GFCI's. It is suggested that a "Licensed Electrical Contractor" be contacted for further evaluation and repair.

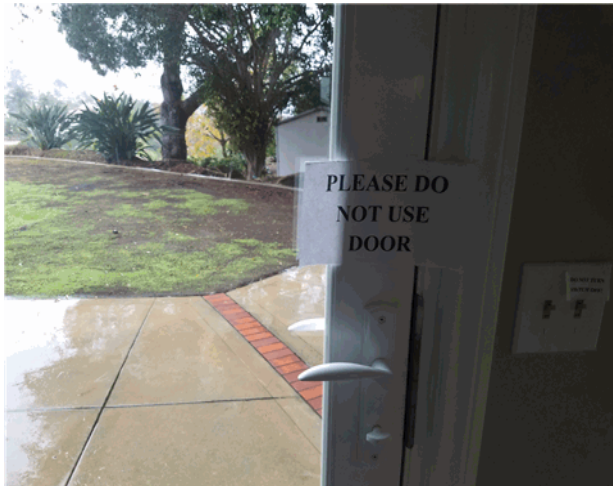
**10) Exterior Door Conditions** R One door in the 1st floor hallway was labeled "do not use" I did not test this door. The pull-down ladder to the roof was also labeled not to use.

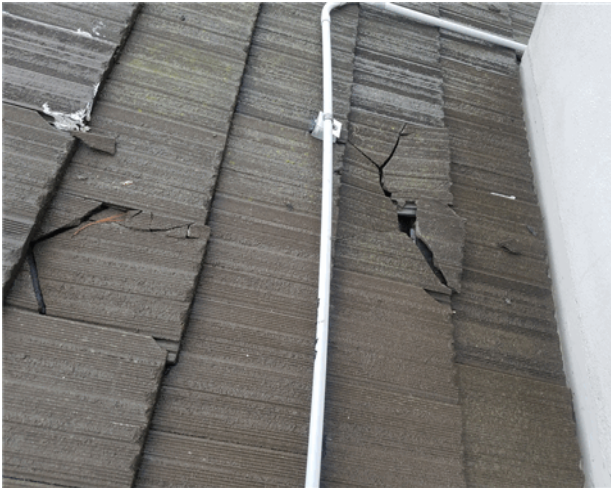
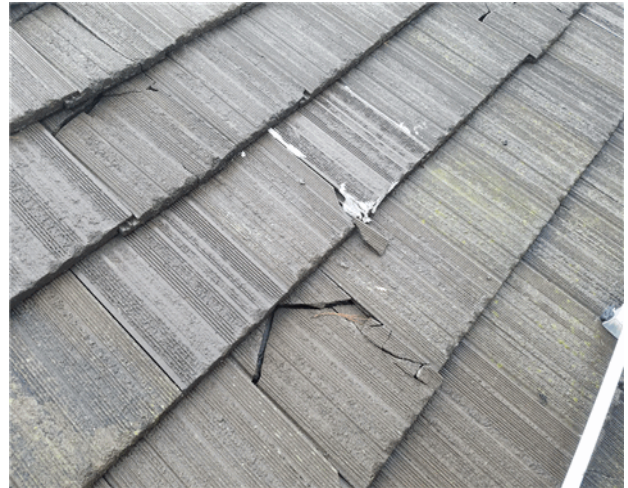
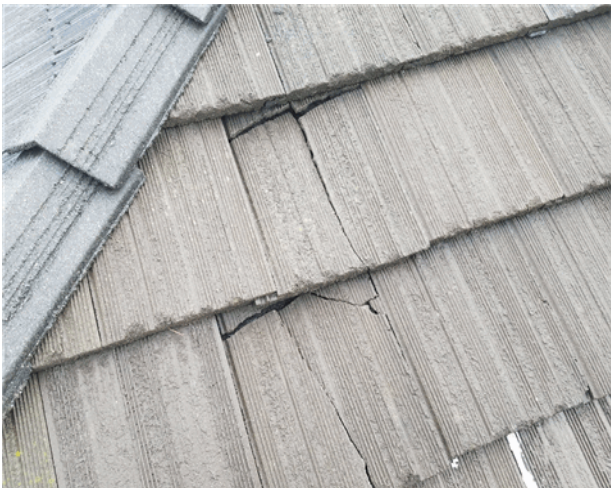
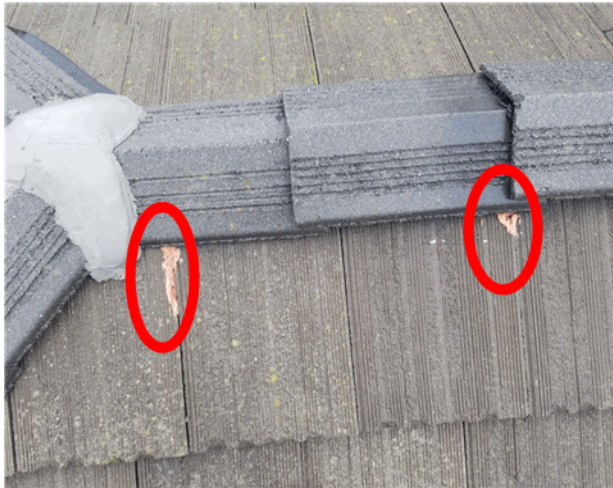
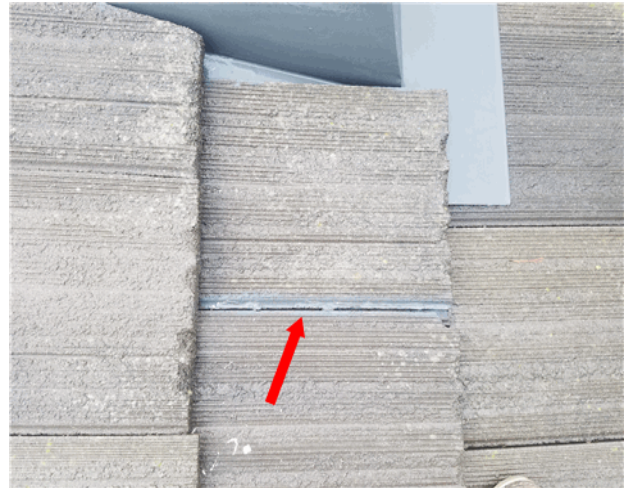
**13) Roof Covering Condition** R There are several broken tiles. The roof had evidence of unprofessional patching and repair. Given this condition, it is likely that the roof has leaked at one time. Recommend further evaluation by a qualified contractor.

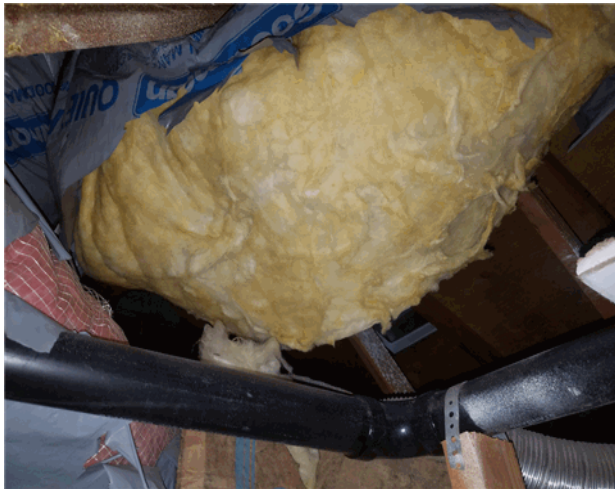
**19) Distribution Conditions** R In the attic there is ducting that the insulation is coming off of. It is suggested that a "Licensed HVAC Contractor" be contacted for further evaluation and repair.

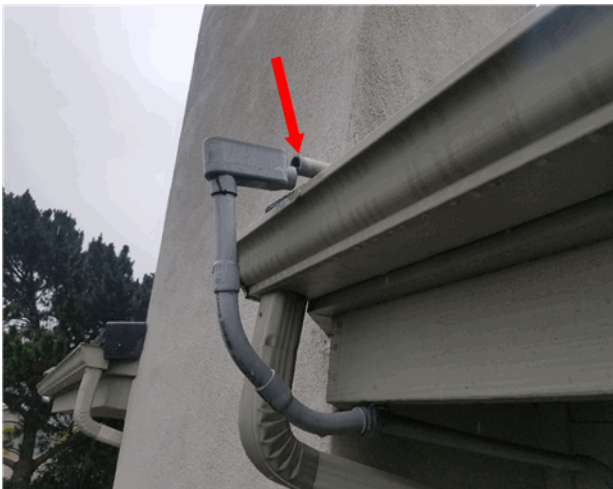
**23) Electrical Service Conditions**      S The conduit for the solar panels is loose from where it was glued to the roofing. There is conduit seperated from a box connector.

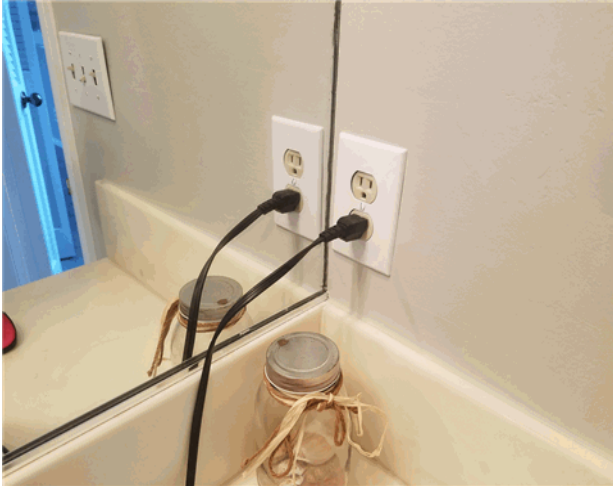
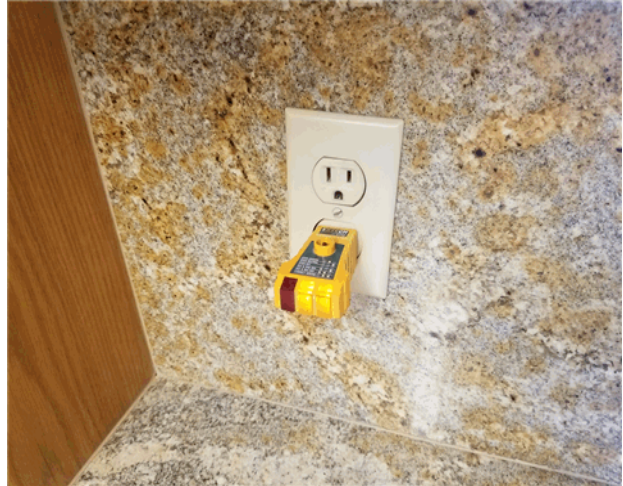
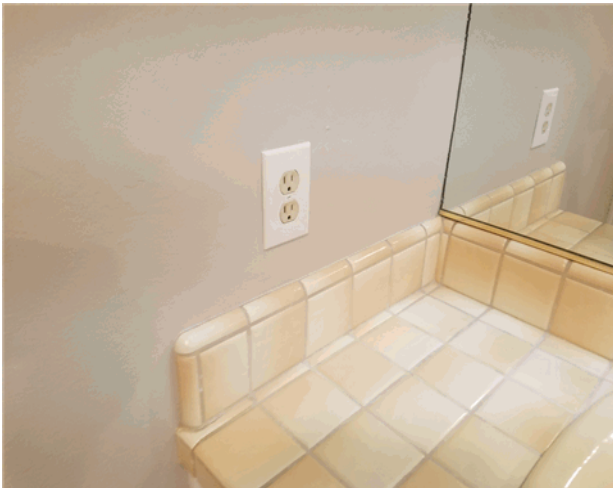
**37) Electrical Conditions**

GFIC (Ground Fault Interrupter Circuit) receptacles (a safety device for outlets near water) are recommended at all bathroom(s), kitchen, exterior, and garage (if present). It is suggested that a "Licensed Electrical Contractor" be contacted for further evaluation and repair.

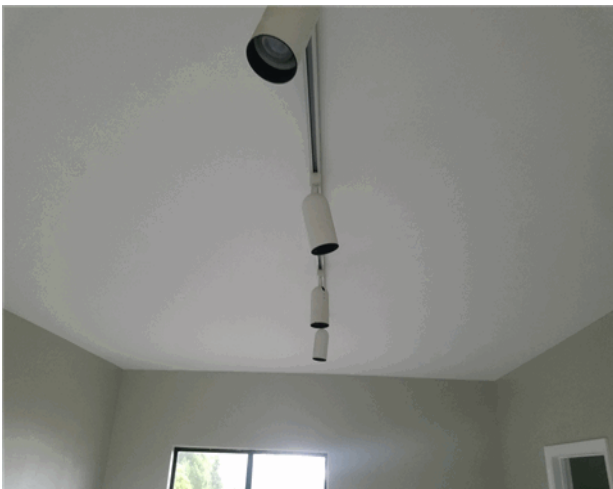
**38) Lighting Conditions**

The track lights in the 1st floor south bedroom did not operate.

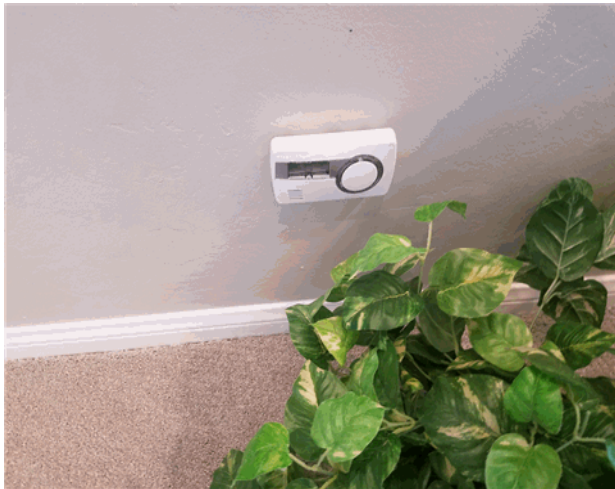
**40) Smoke Detector  
Conditions**

The CO detectors were not working at the time of inspection.

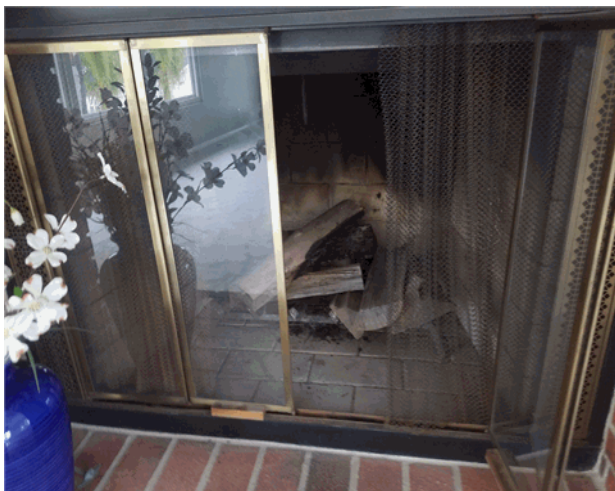
**41) Fireplace  
Conditions**

The flue damper was difficult to operate at the time of inspection. Adjustment and / or repairs are recommended. It appears to not open enough.

The left side glass door did not open.

It is suggested that a "Licensed General Contractor" be contacted for further evaluation and repair.

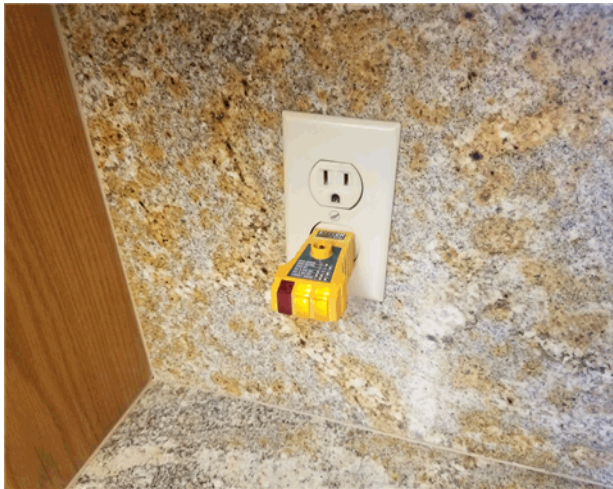
- 48) Electrical Conditions
S
None of the outlets are GFCI protected. It is suggested that a "Licensed Electrical Contractor" be contacted for further evaluation and repair.

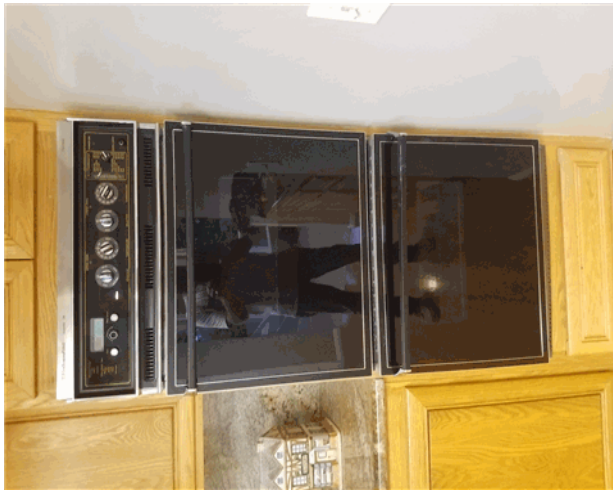
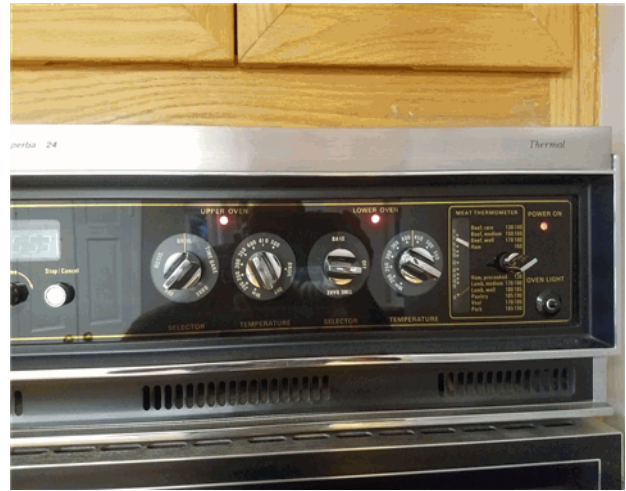
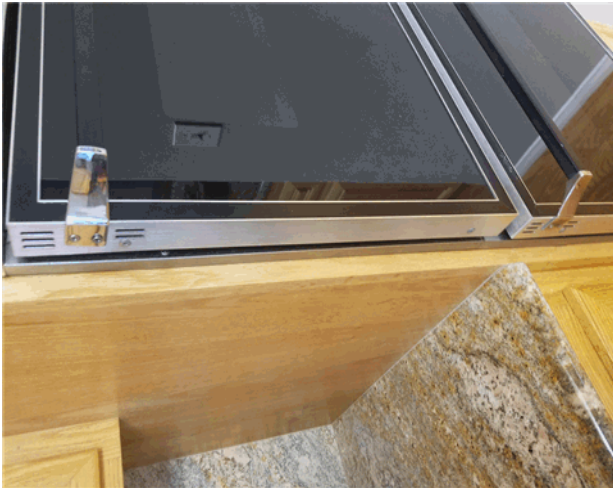
**55) Stove - Range Condition**

Both ovens didnot operate. The burners wouldn't light. The igniters were glowing. It is suggested that a "Licensed General Contractor" be contacted for further evaluation and repair. The handles for both ovens are loose.

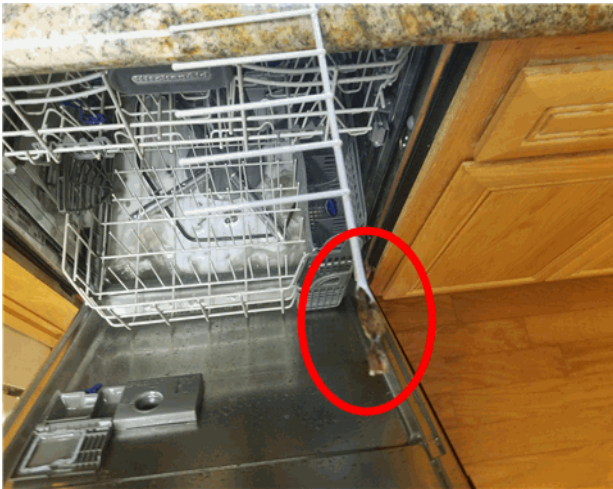
**57) Dishwasher Conditions**

The dishwasher appeared to be in serviceable condition at the time of the inspection. This does not however guarantee future performance or conditions. There is a damaged/seperated piece of the dish holder.

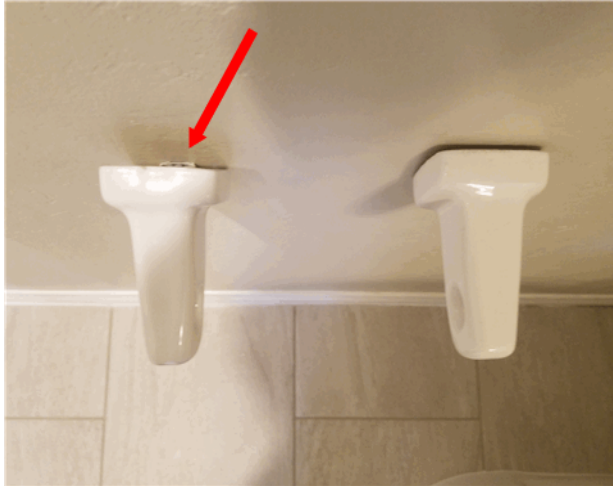
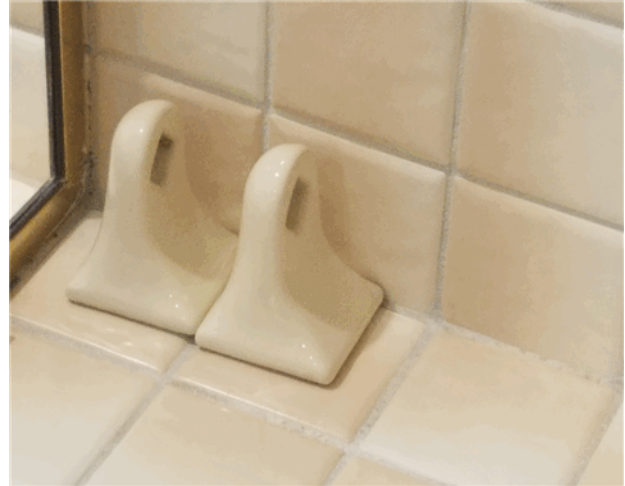
**58) Wall Conditions**

The toilet paper holder is pulled from the wall in the 1st floor bathroom. There is no toilet paper holder mounted in the master bathroom.

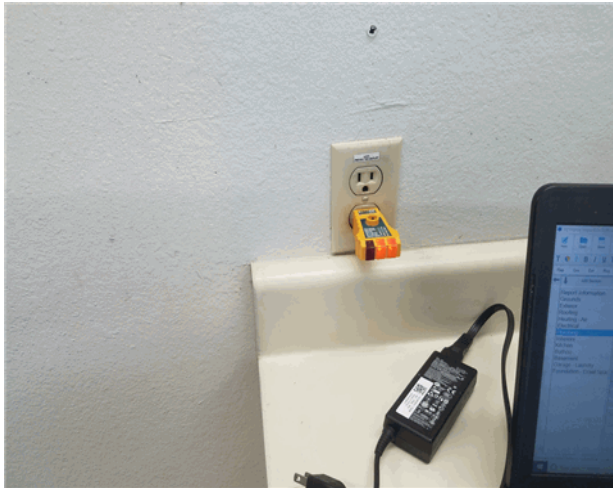
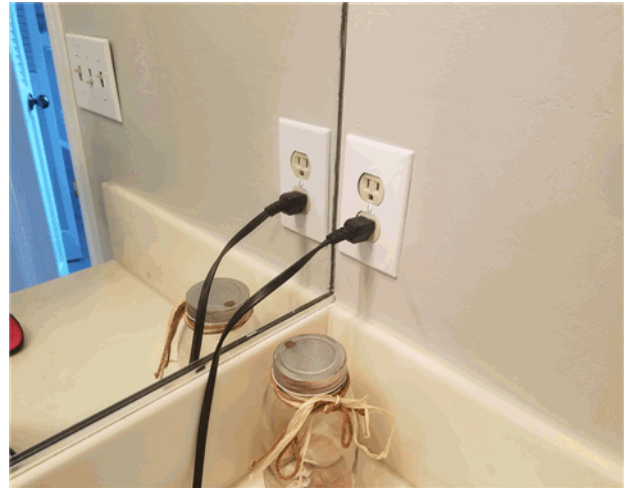
**64) Electrical Conditions**

GFIC (Ground Fault Interrupter Circuit) receptacle circuit (a safety device for outlets near water) recommended at all bathroom. It is suggested that a "Licensed Electrical Contractor" be contacted for further evaluation and repair.

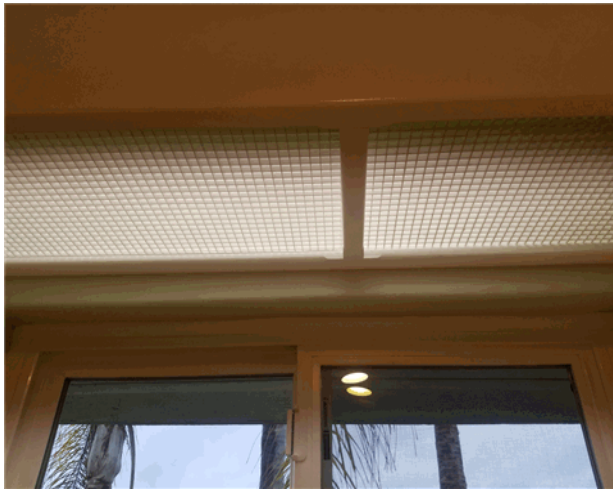
65) Lighting Conditions

Master bathroom flurescent lights are flickering.

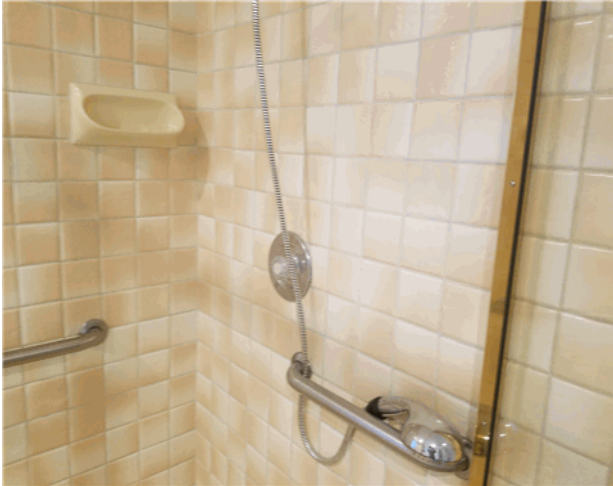
69) Shower - Tub Conditions

The shower head holder is missing in the master bathroom. The shower door in the master bathroom sticks on the bottom.

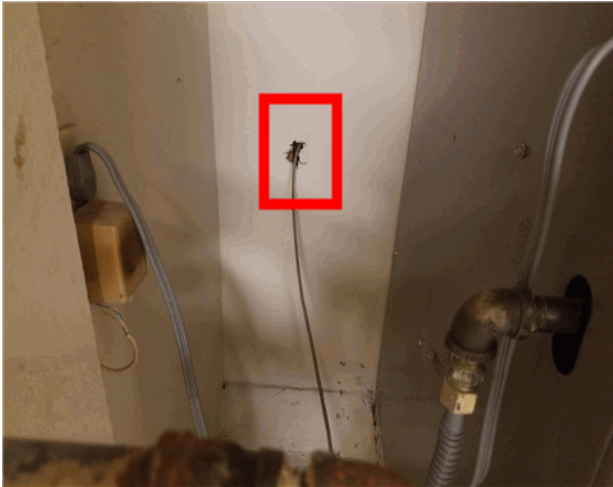
**71) Wall Conditions**

The general condition of the walls appeared to be in serviceable condition at the time of the inspection.  
There is a hole in the furnace closet wall from the thermostat wire that needs to be patched. This is a fire hazard.

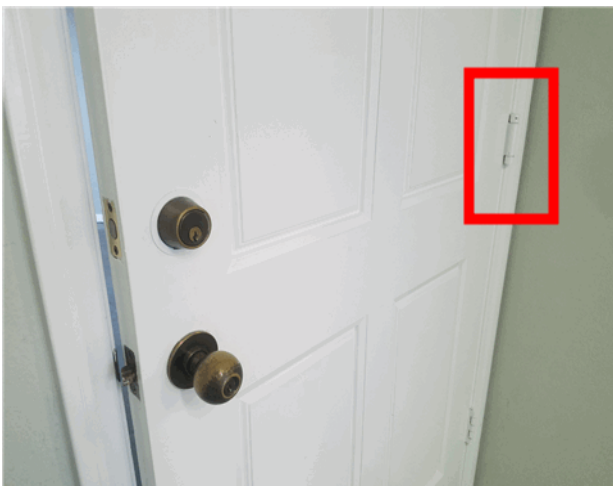
**75) Door Conditions**

The door from the garage to the house does not close and latch. Recommend adjusting the self-closing hinge. This is a fire hazard.
